Dynamic Tests Of Five Breakaway Lighting Standard Base Designs

## DYNAMIC TESTS OF FIVE BREAKAWAY LIGHTING STANDARD BASE DESIGNS

**NO. M & R 636408**

DYNAMIC TESTS OF  
FIVE BREAKAWAY LIGHTING STANDARD BASE DESIGNS

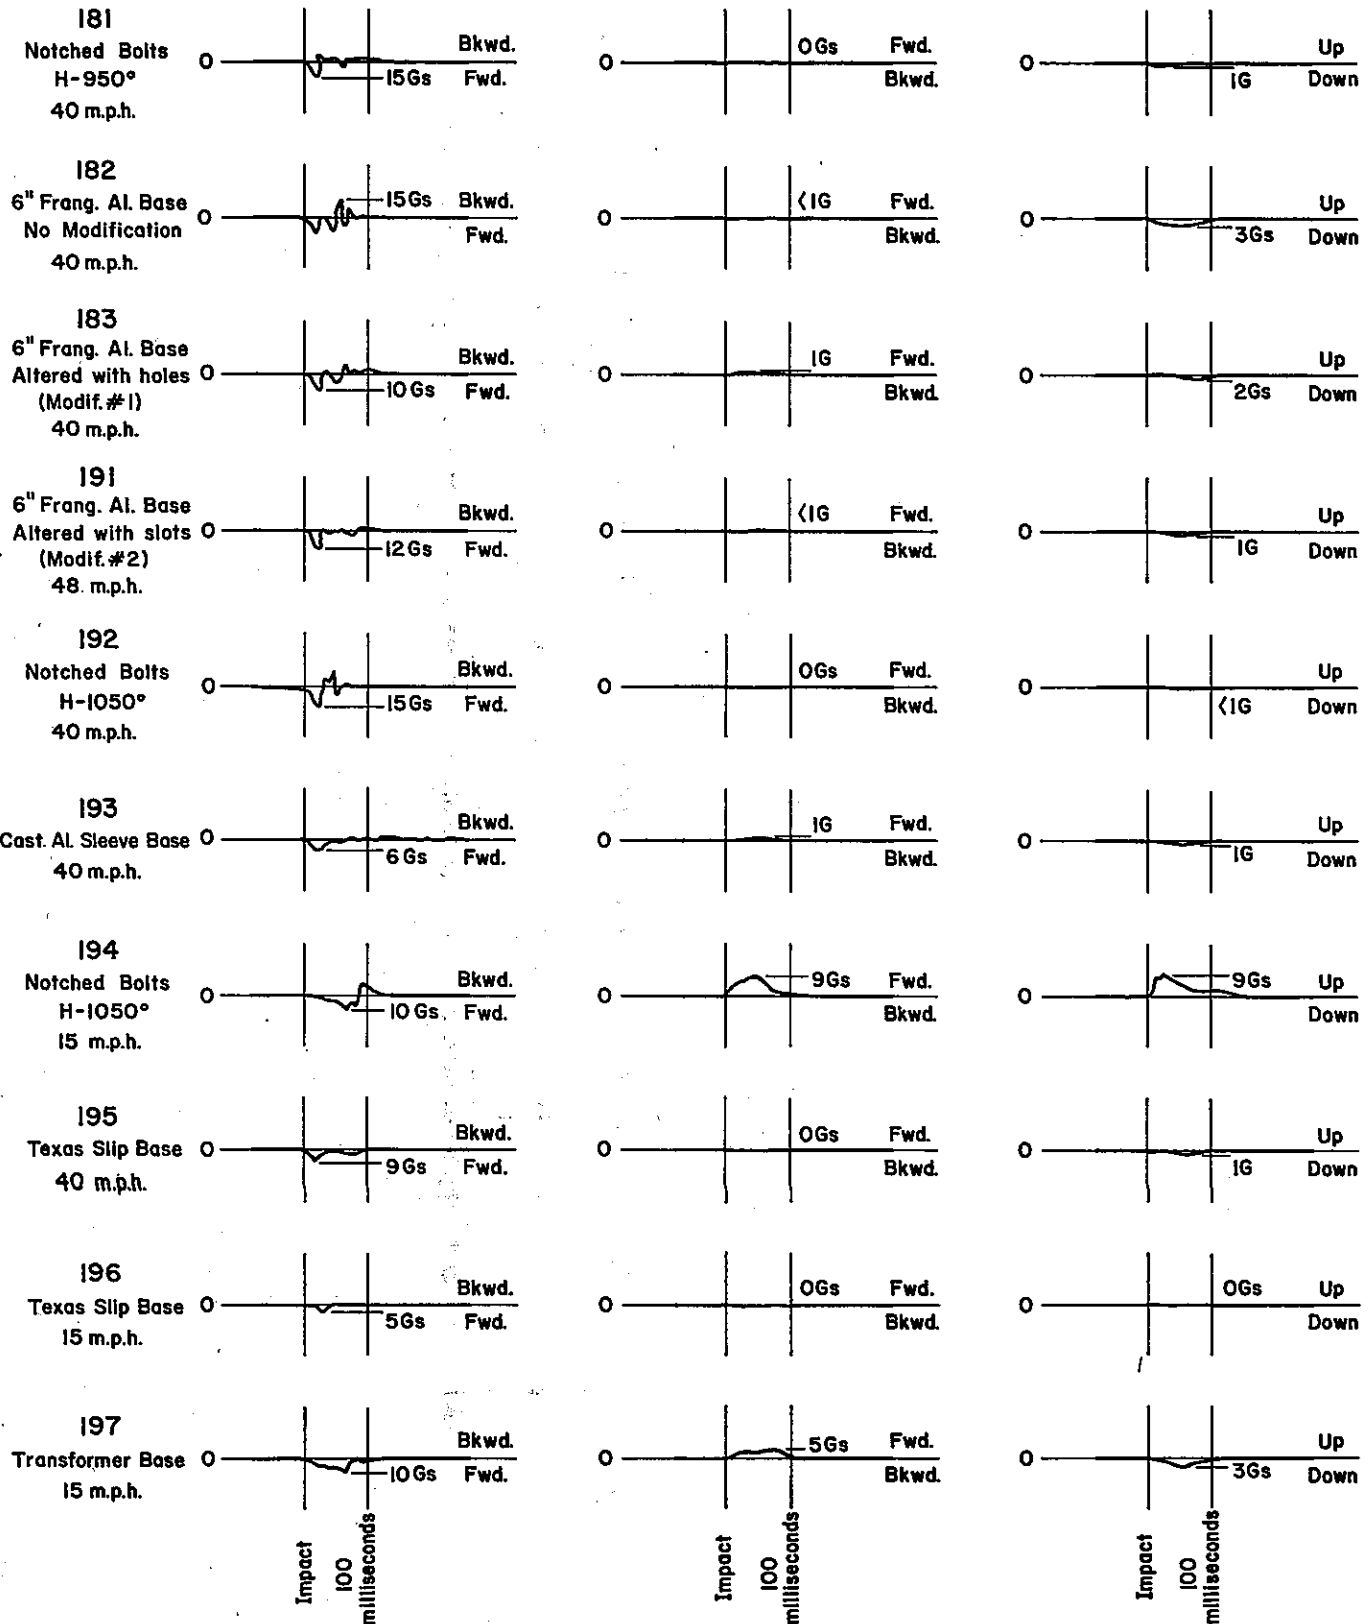
TEXAS SLIP BASE ADAPTER  
TESTS 195 AND 196

Two impact tests were conducted using a multi-directional slip base adapter patterned after (and very similar to) that developed and tested by the Texas Transportation Institute. However, some modifications were necessary to accommodate the California Type XV steel pole base configuration. Details of the design tested are shown in Plate 7.

The two 18-1/4-in. diameter 1-in. thick mild steel plates on the slip base were held together with three 1-1/4-in. black bolts conforming to ASTM Designation A-307 (Figures 9 and 10). Bolt torque was approximately 50 ft-lb which is equivalent to about 2000 lbs. bolt tension. Each of the top washers was pinned to the upper 1-in. plate with two 1/8-in. shear pins to prevent the bolts from walking out of the slots due to wind vibration.
